## BRIDGE NO. 06296

15350 - CLINTON  
WATERSIDE LANE  
over  
HAMMOCK RIVER

Routine and Special Inspection

10/23/2024

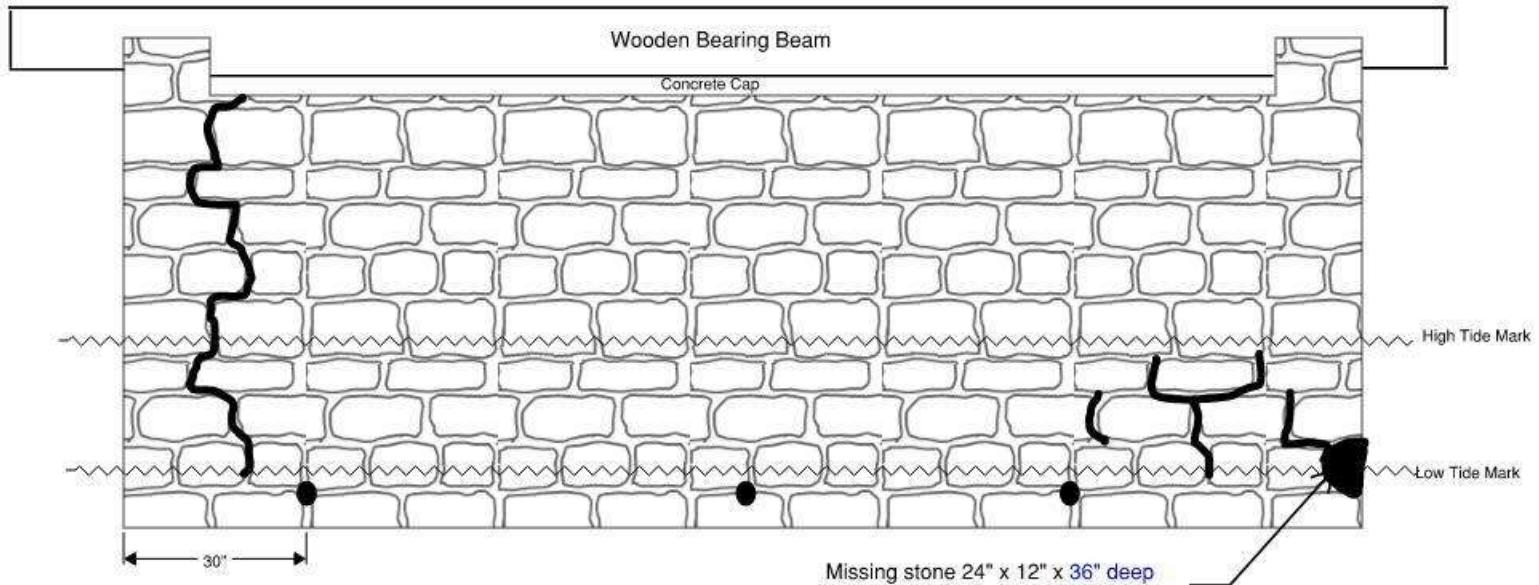
**ABUTMENT # 1(N.T.S)****LEGEND:**

General notes: Numerous areas of missing mortar and stones , cracking in joint areas, displacement of stones, bulging areas

Replace and Repair the loose, displaced and missing stones in the substructure.

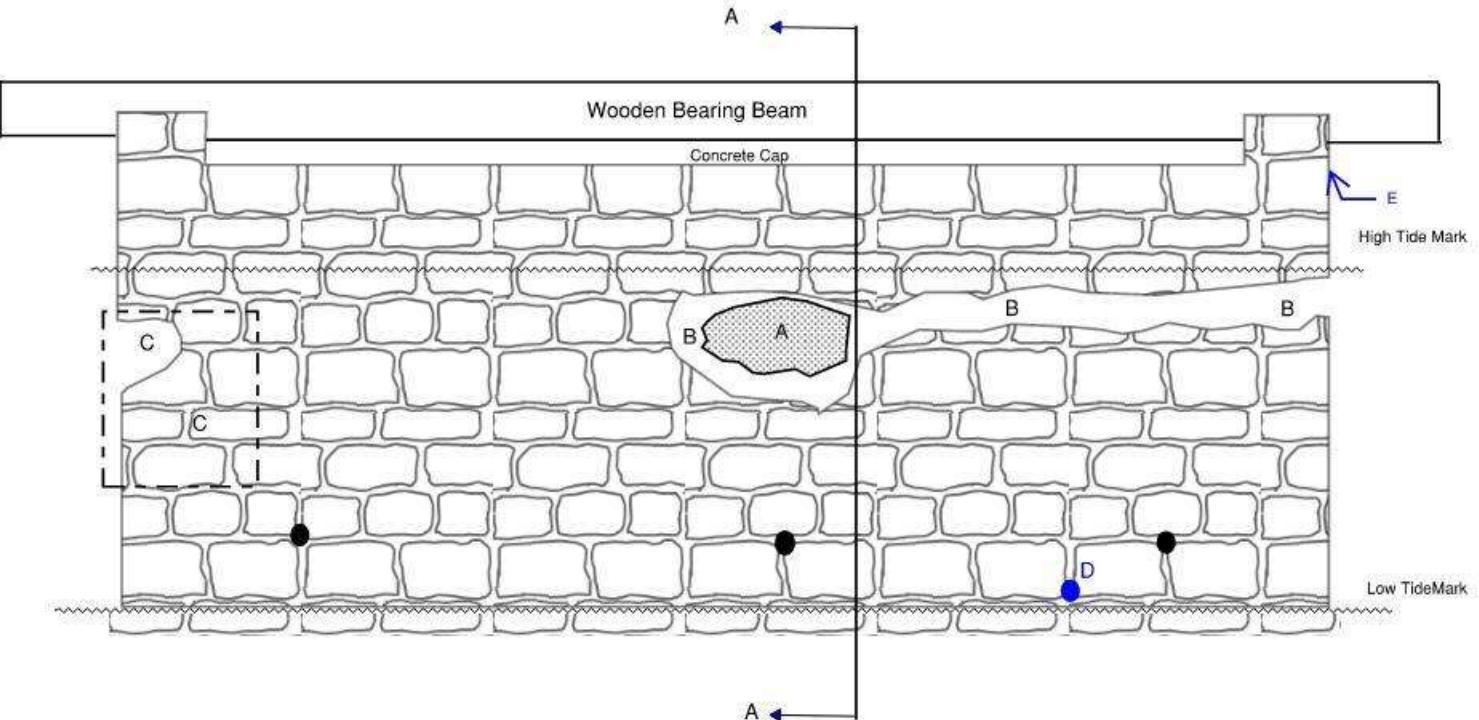
A. Remains of concrete abutment with heavy scale and punky concrete

B. Large area of missing stones approximately 10' x 20" x 43" deep. This area continues around into the northeast wingwall approximately 30" x 16". The top coarse of stones in the voided area B is suspended and the lower coarse are loss and moveable.

C. Area of missing, and displaced stones and voided area under concrete abutment

E. Northeast wingwall beyond timber support shows meandering cracks along mortar joints up to 2/16" indicating some small settlement of abutment movement to the other side.

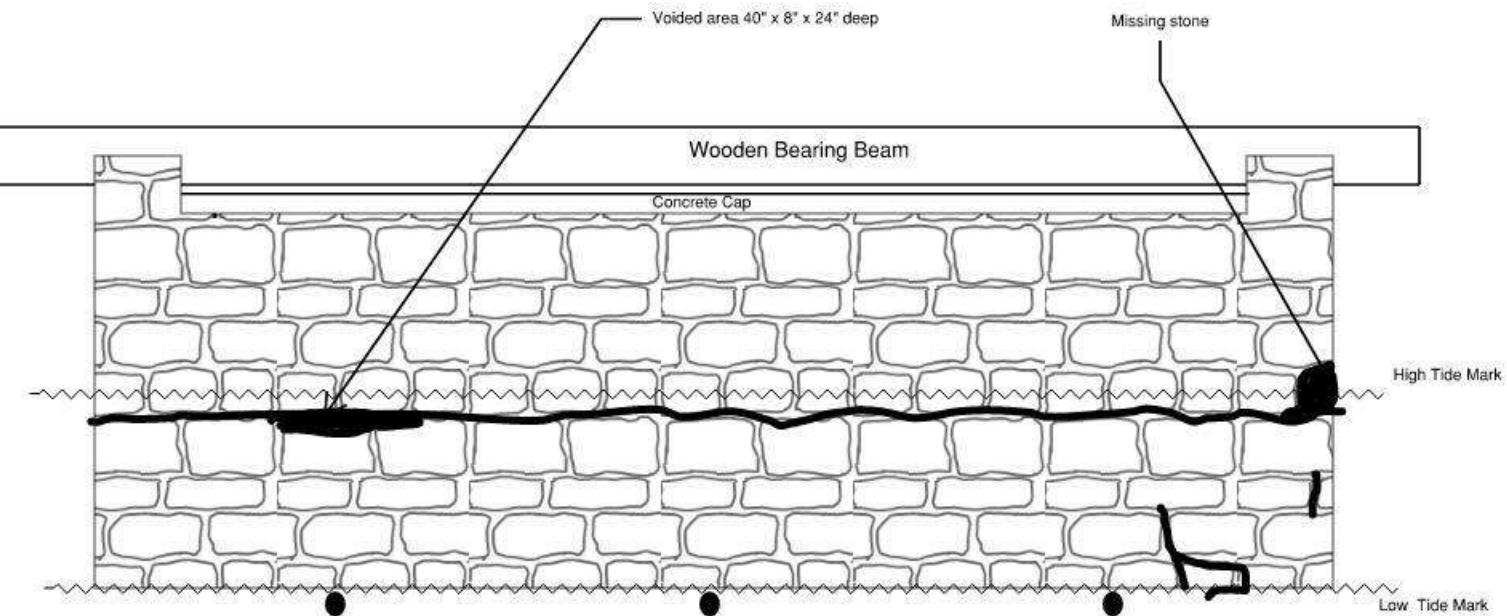
**PIER SOUTHFACE (N.T.S)****LEGEND:**

Pier south fascia  
 Voided area 40" x 8" x 24" deep at west end of pier.  
 Missing stone at east end.  
 Full width missing stones and mortar at high tide mark up to 24 inches deep.

General notes: Numerous areas of missing mortar and stones , cracking in joint areas, displacement of stones, bulging areas

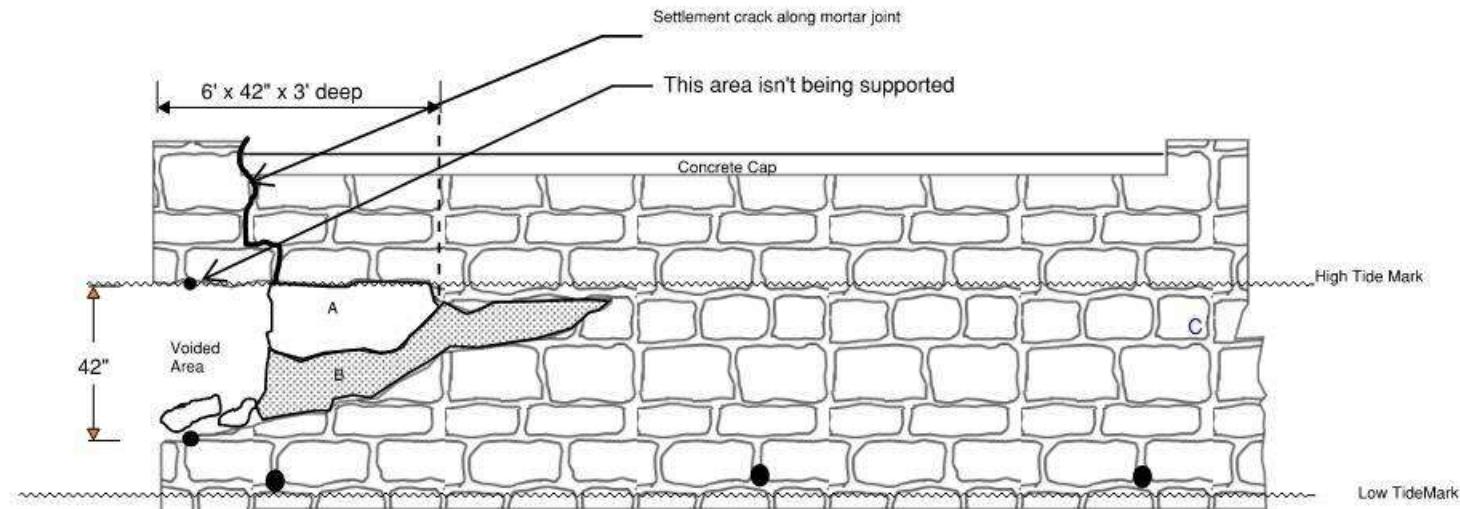
A. Exposed concrete abutment behind stones facade exhibits sever punky concrete

B. Severe scale and punky concrete on face of the abutment with displaced stones.

General notes: Numerous areas of missing mortar and stones, cracking in joint areas, displacement of stones, bulging areas

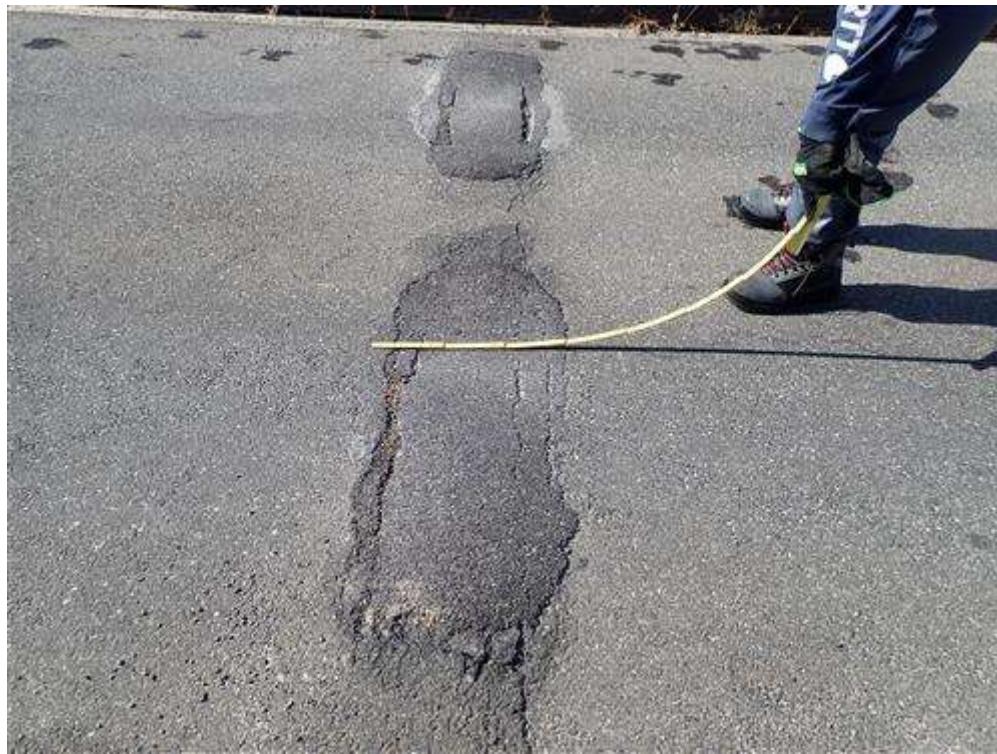
Photo Number: 5

There are two bituminous patches with raveling, and in the center of the bridge there is a full width heaved area with some bituminous cracking 45" x 15".

Multiple heaved up areas (overlay)

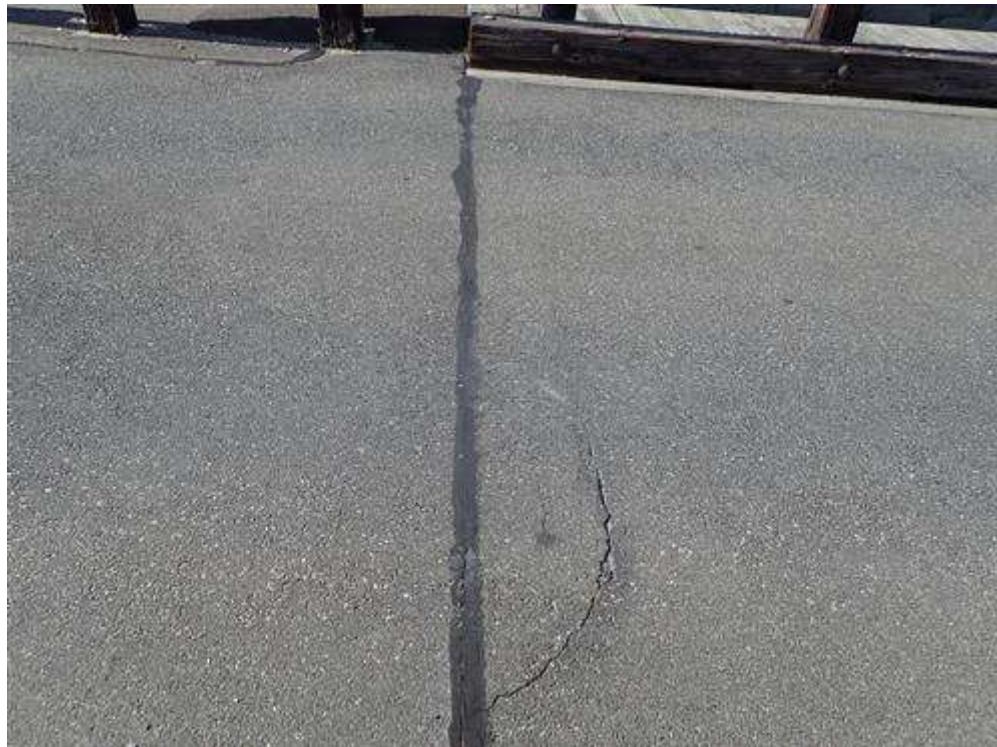
Photo Number: 6

Kerf cut joint over abutment 1

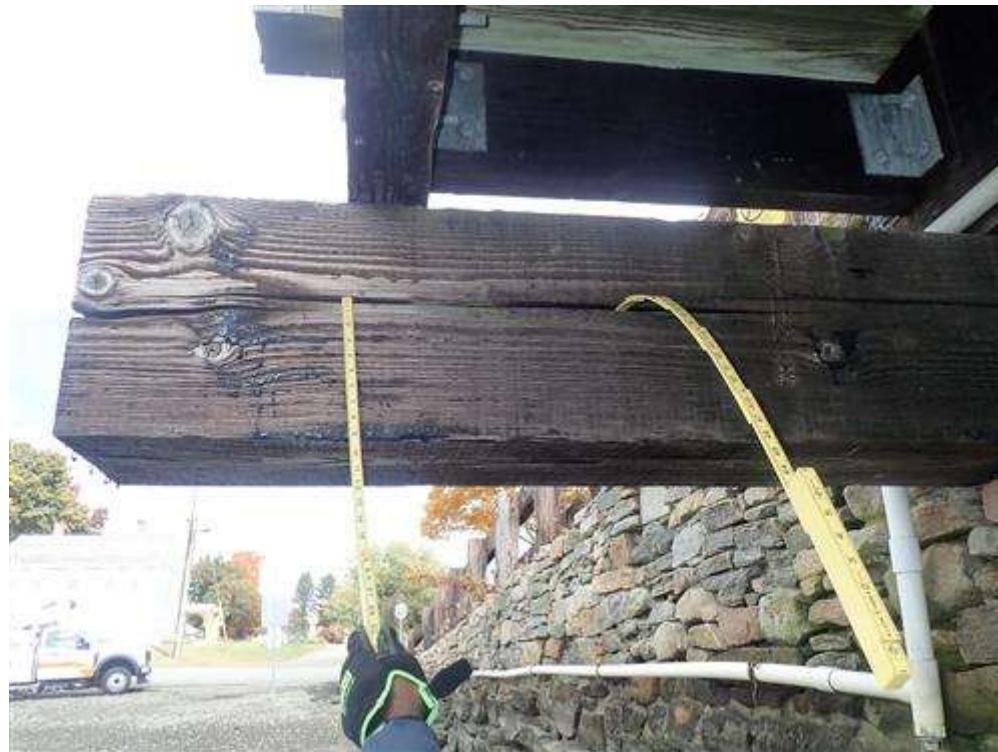
Photo Number: 13

Checks and splits open to 1/4" x random lengths.

Transverse spreader beam over abutment 2 split on the west end

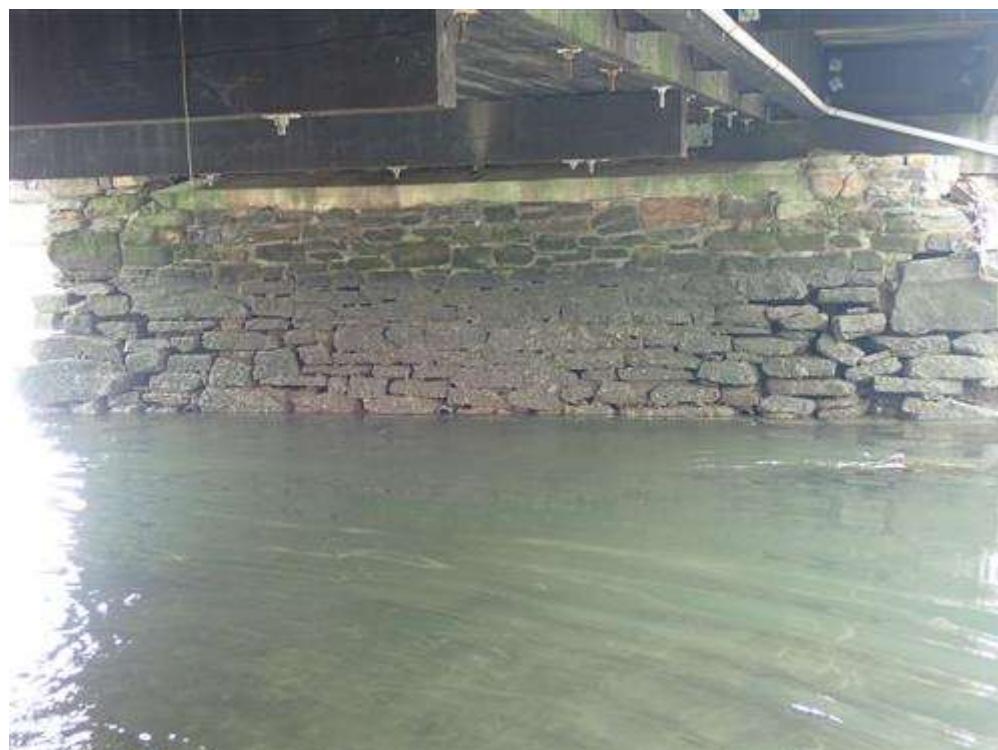
Photo Number: 14

Abutment # 1  
 Missing stones at southwest corner 24" x 12" x 36" deep.  
 Missing mortar.  
 Mortar cracking

Abutment 1

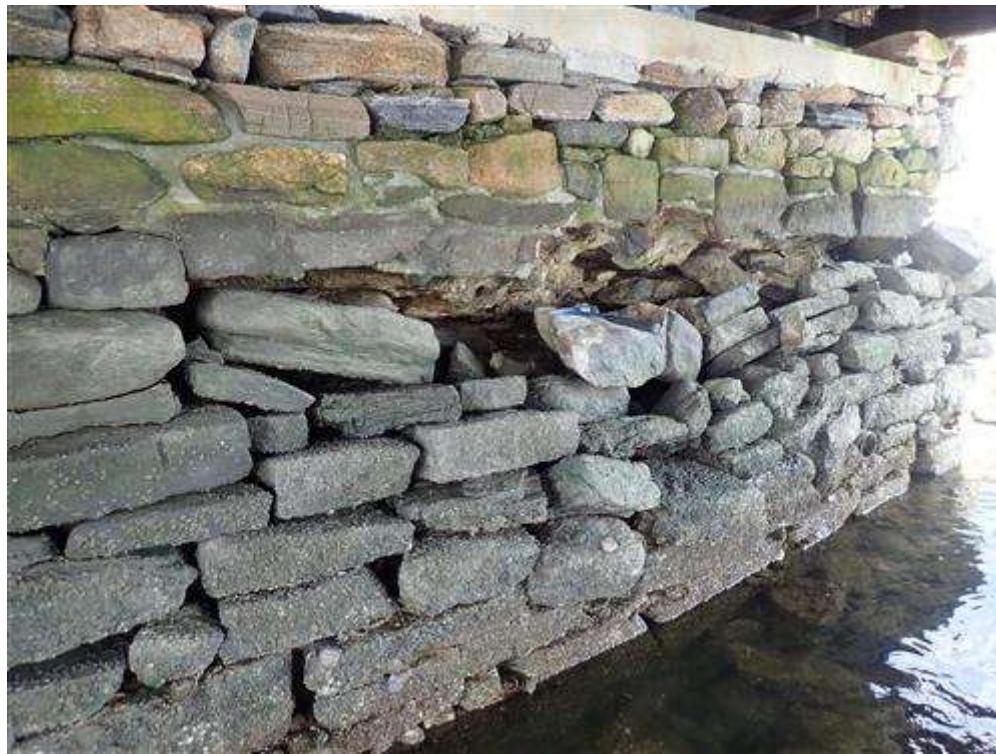
Photo Number: 17

Abutment # 2  
 Large voided area 10' x 20" x 43" deep.  
 Missing and loose stones.  
 Monitoring points are spray painted for future measurements.  
 Concrete abutment exposed behind stone facade with punky concrete abutment

Abutment 2 void

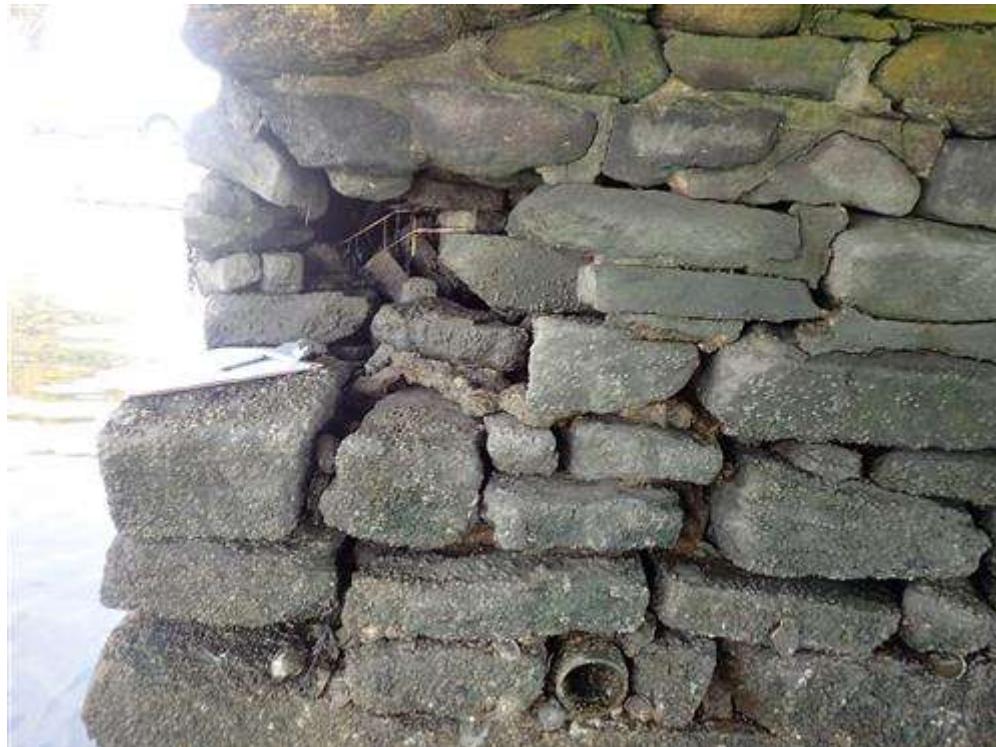
Photo Number: 18

Abutment 2 corner void at west end

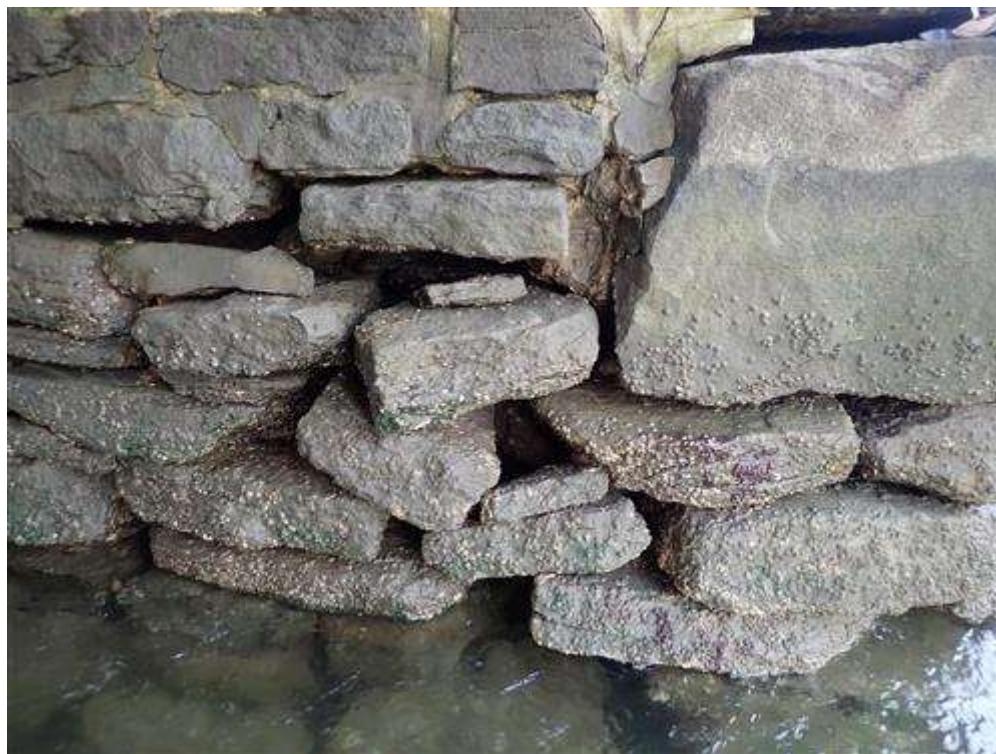
Photo Number: 19

Multiple void areas in abutment 1 (on both sides)

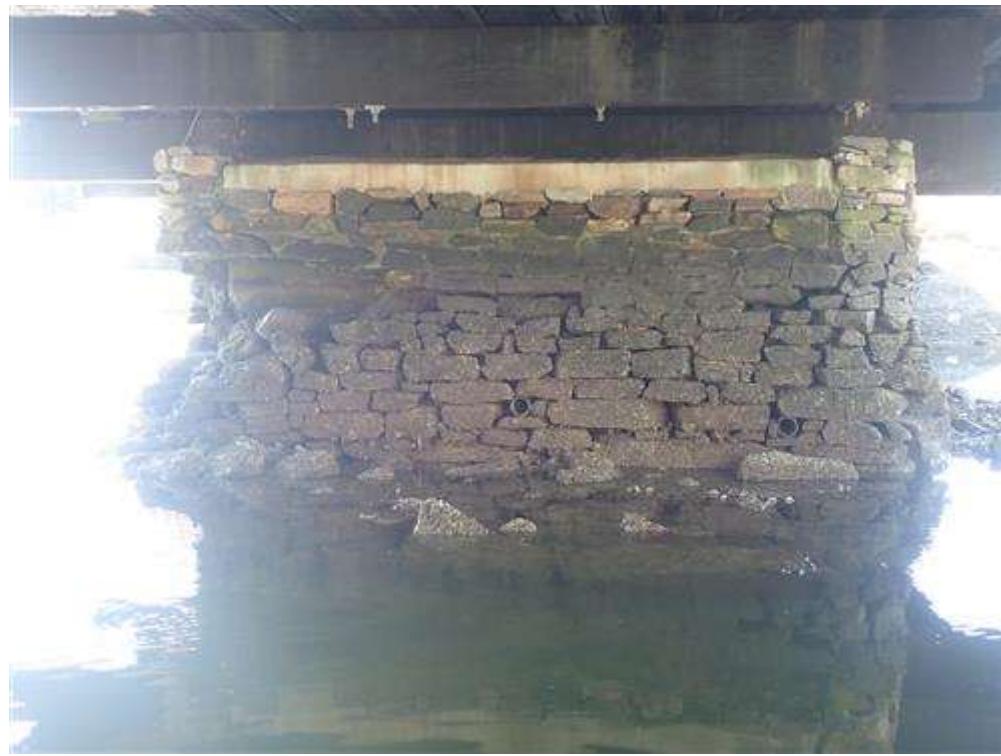
Photo Number: 21

Pier north facia  
 Large area of missing stones at east end 6'x 42" x 3' deep. A portion of the area isn't being supported due to voided area.  
 Monitoring points are spray painted for future measurements.  
 Concrete abutment exposed with severe punky concrete.  
 Settlement cracking.

North side of pier

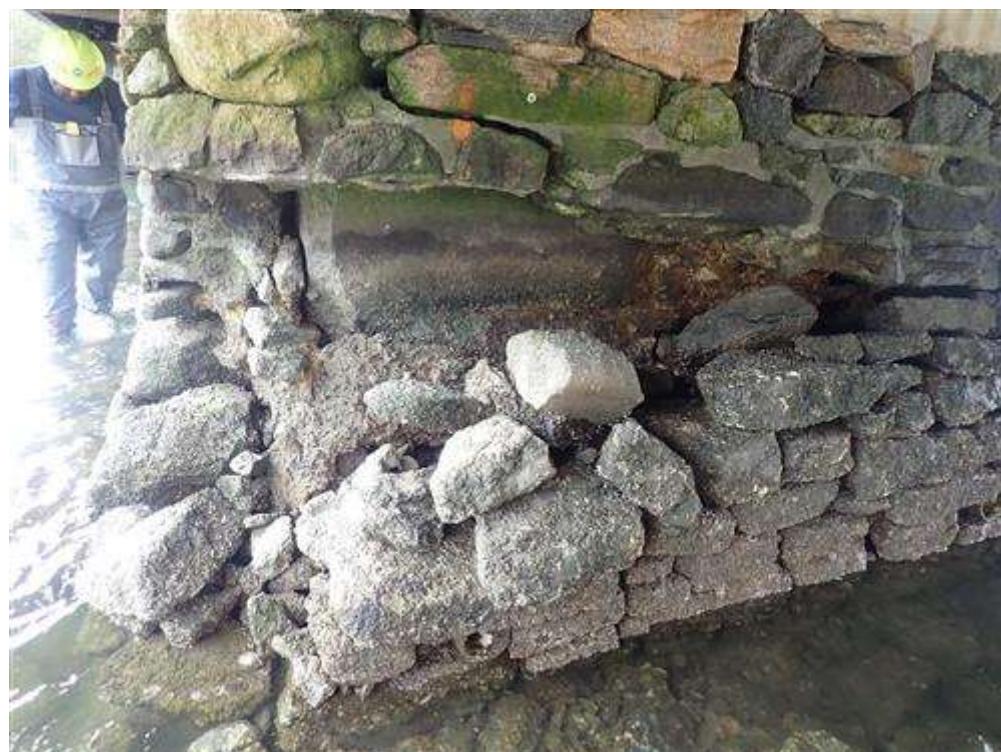
Photo Number: 22

Large void in pier on northeast corner of the pier

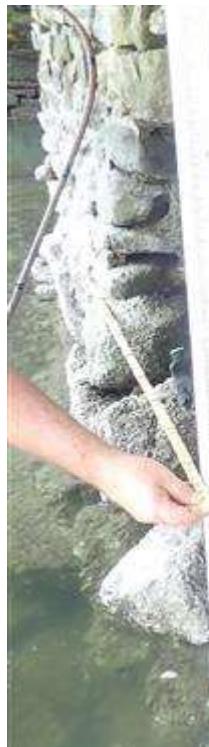
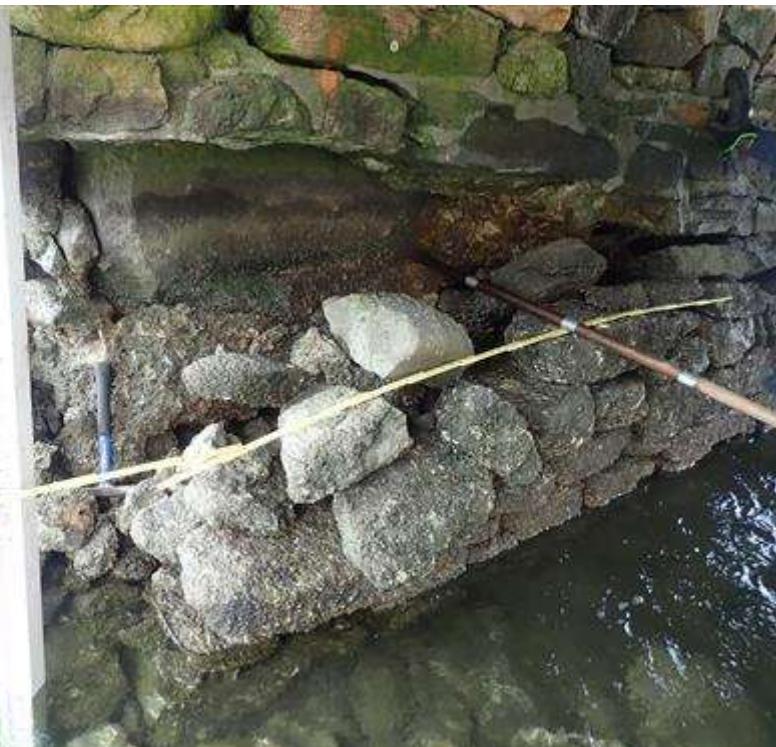
Photo Number: 23

Same as previous location

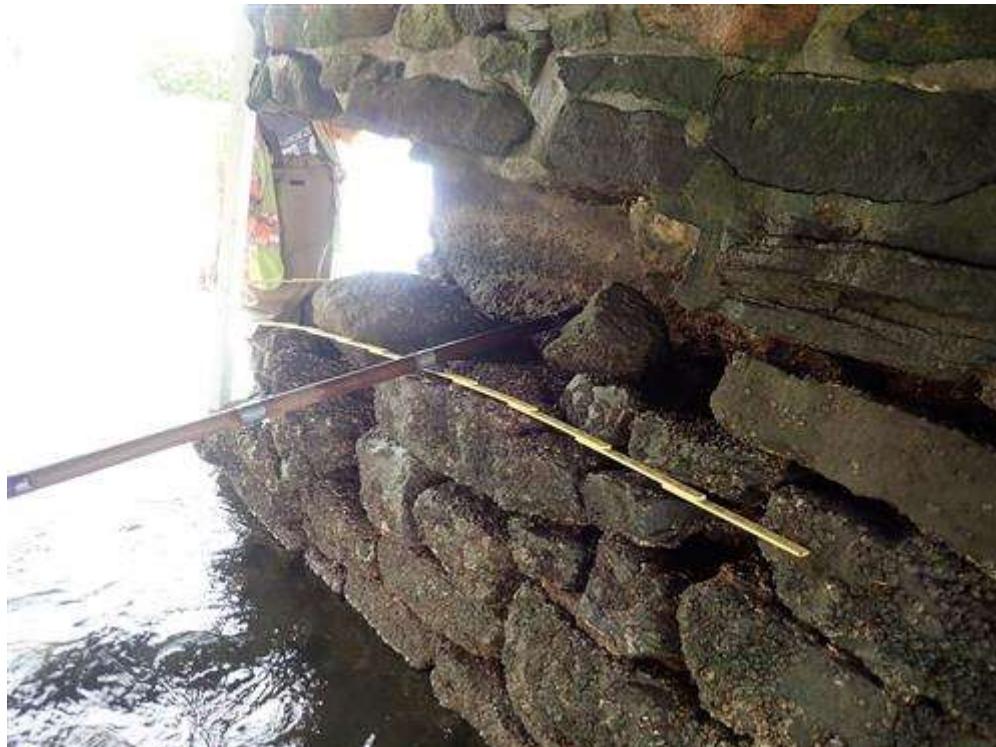
Photo Number: 24

Same as previous location

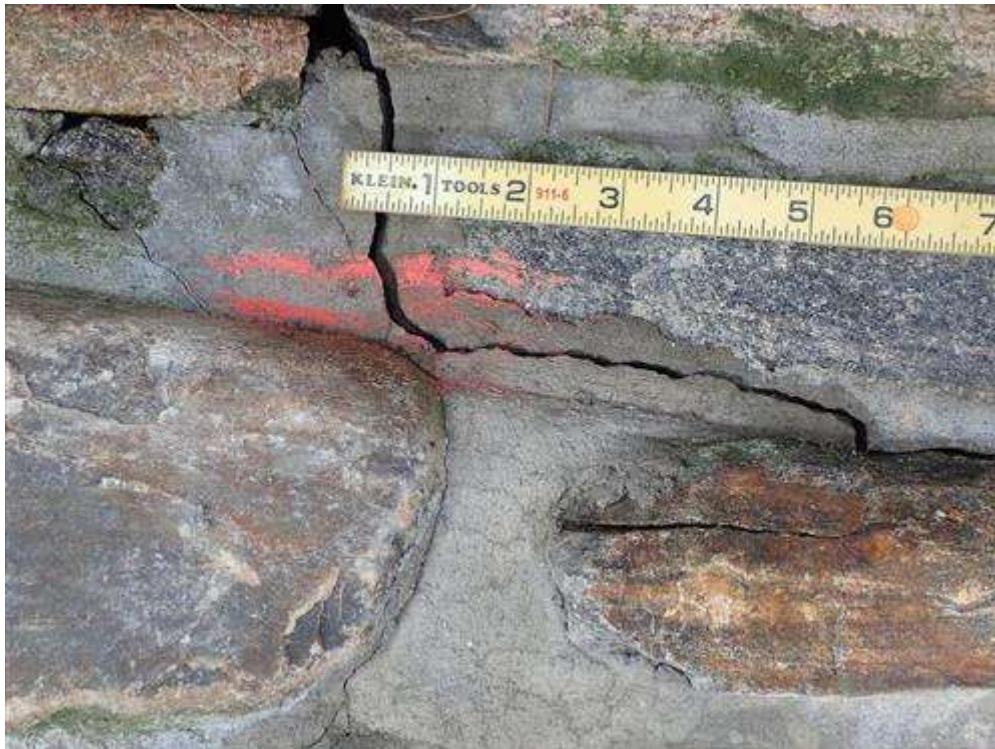
Photo Number: 26

Settlement crack at wingwall 2B (northeast) meandering.

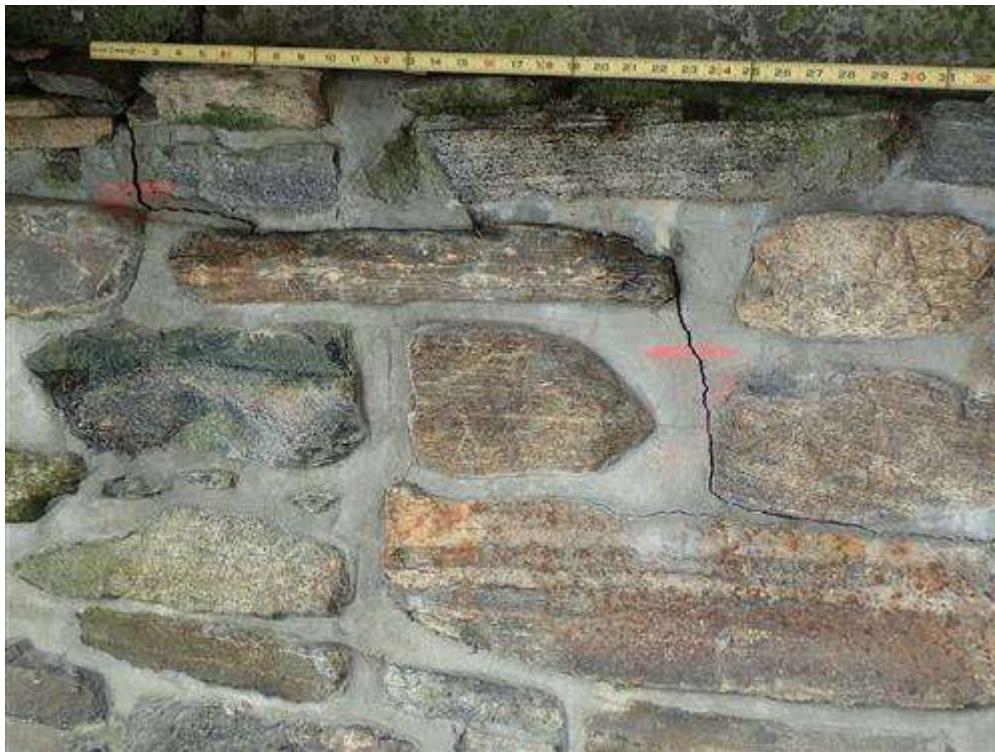
Photo Number: 27

Same as previous location
